BEHAVIOR OF SEALING MATERIALS / POLYMERS UNDER DEEP GEOTHERMAL OPERATING CONDITIONS

H. – J. Friedrich¹, R. Brüll², D. Zschornack¹

¹ Fraunhofer – IKTS, ² Fraunhofer-LBF

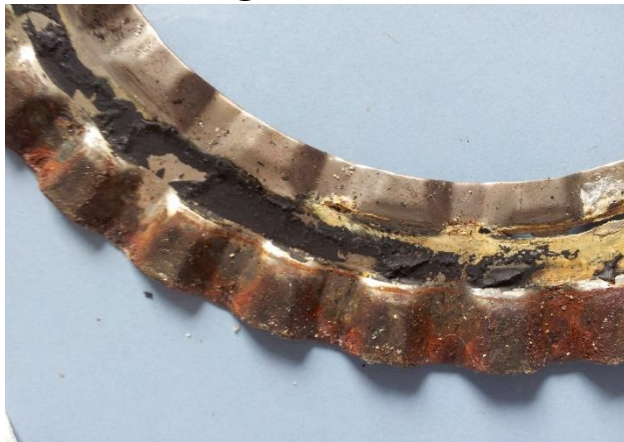
damaged sealing on Ti-plate

- Sealing systems are an important but often underestimated part of geothermal installations
- Function: Sealing of the system internally and externally, partly also compensation of dimensional changes, damping of vibrations
- In geothermal plants typically up to several 1.000 sealings/gaskets may be in use, mostly in plate heat exchangers
- Degradation or damage of sealing material is often the reason for further and also severe damages of components because of leakages or secondary material incompatibility
- The following example shows severe damage of Ti-heat exchanger plate starting with decomposition of the sealing material

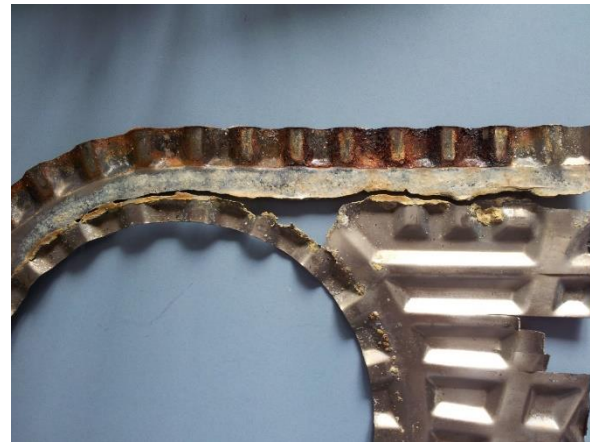
Severe corrosion (mispolarisation of Ti)

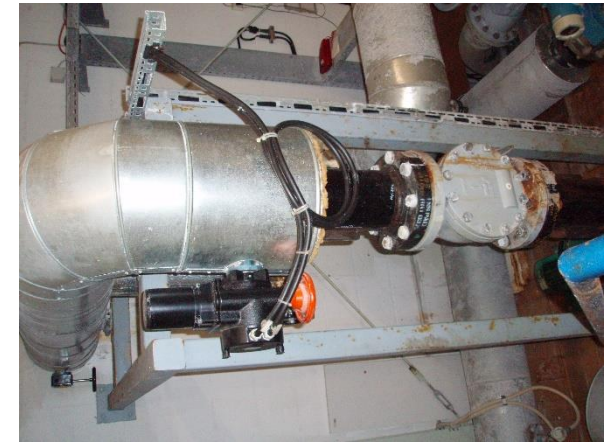
Typical leakage followed by corrosion

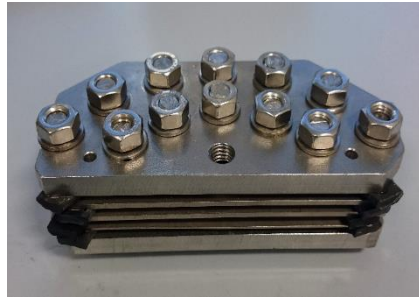
Pre-pressurized with 10 Nm tightening torque

III. Methods investigation – set up for In-situ testing

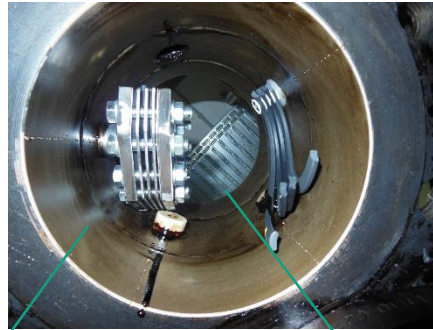
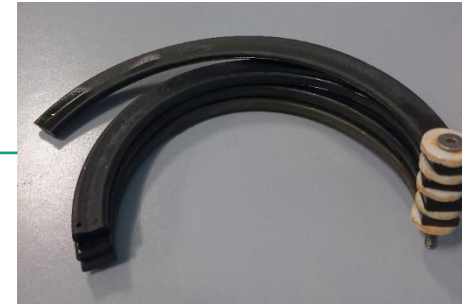
Free exposition

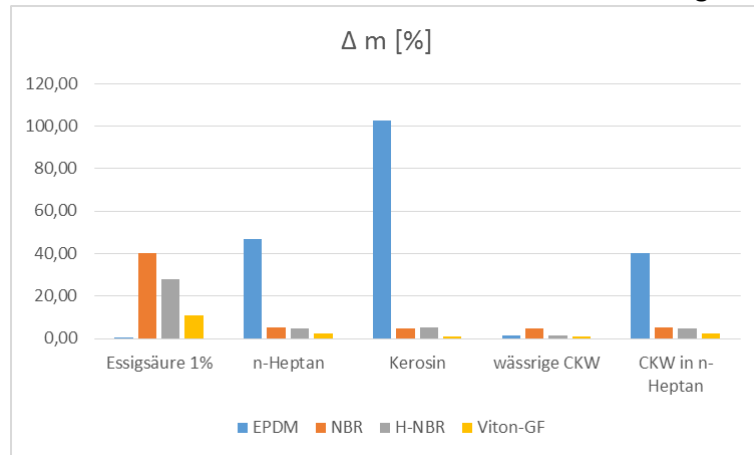
- Materials: EPDM, NBR, HNBR, FKM (Viton® GF)
- Exposition 100 h at 95 °C (+ 334 h in air)
- Media: n-Heptan, Kerosin (C₈- C₁₃-HC), LHC, acetic acid 1% (microbiell metabolism)

- Especially low and middle weight hydrocarbons are critical for EPDM
- High values for volume and mass excesses and also very high losses in shore hardness were observed

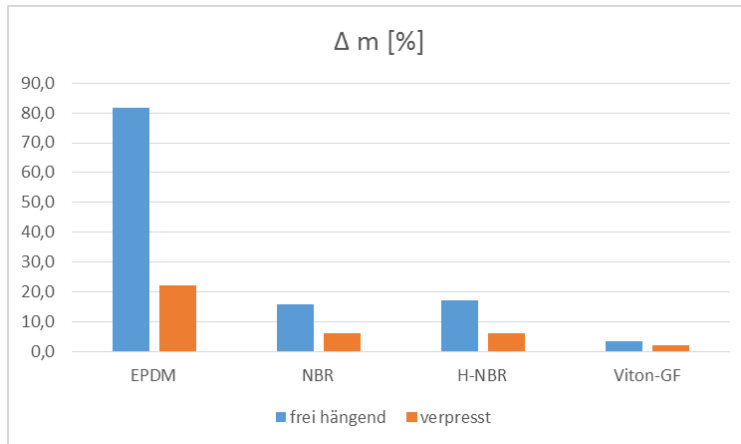
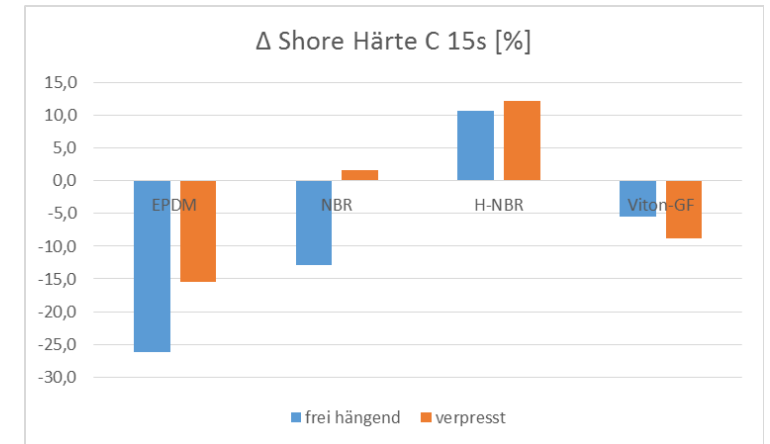
■ Results Pullach

- EPDM shows large changes in mass and volume, NBR, HNBR only slight ones
 - Excluded HNBR reduction in shore hardness is observed, EPDM strong reduction
- EPDM as sealant material in such fluid not suitable

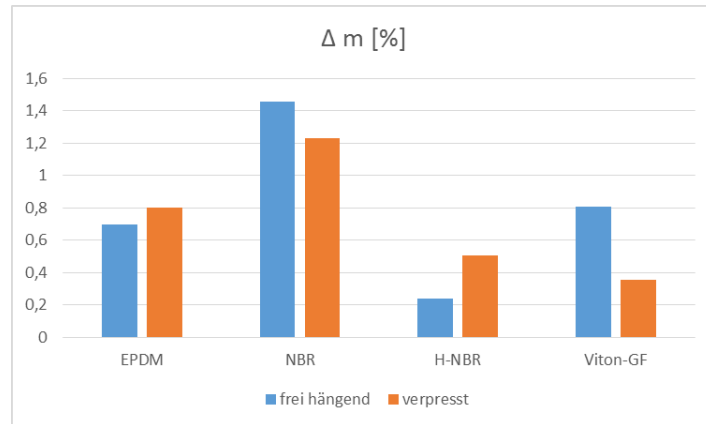
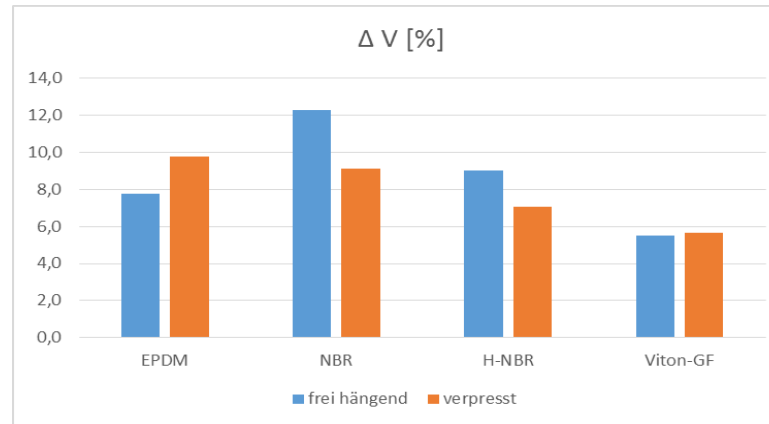
■ Results Neustadt-Glewe

■ In general only slight changes in mass and volume or shore hardness

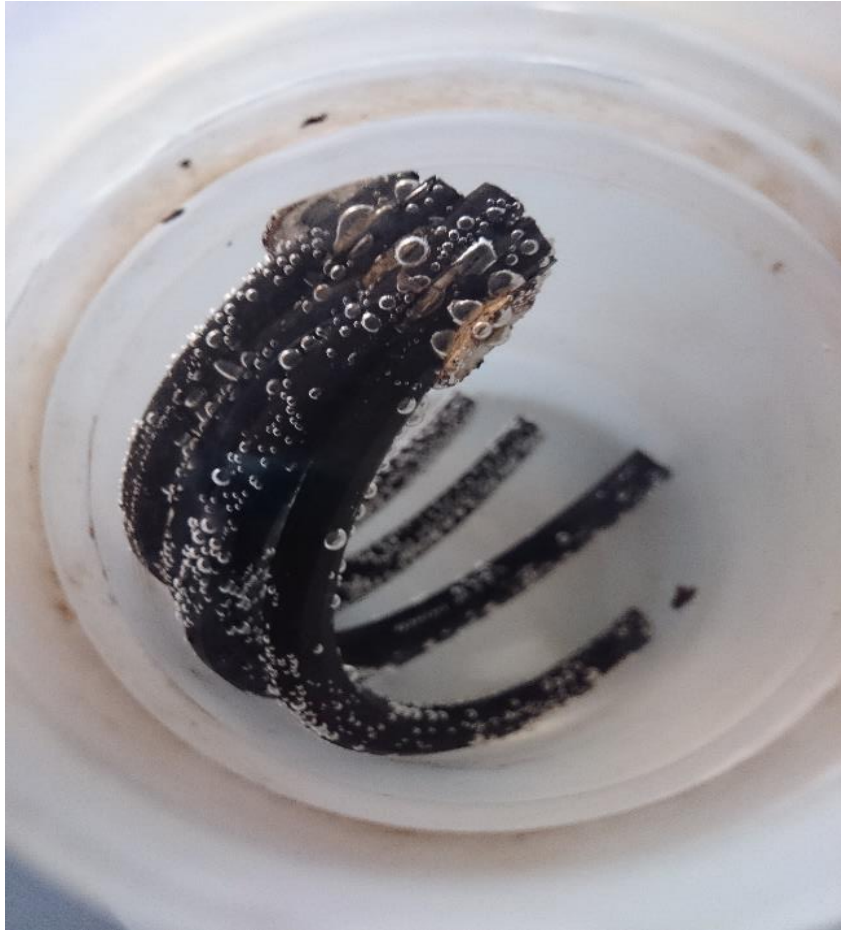
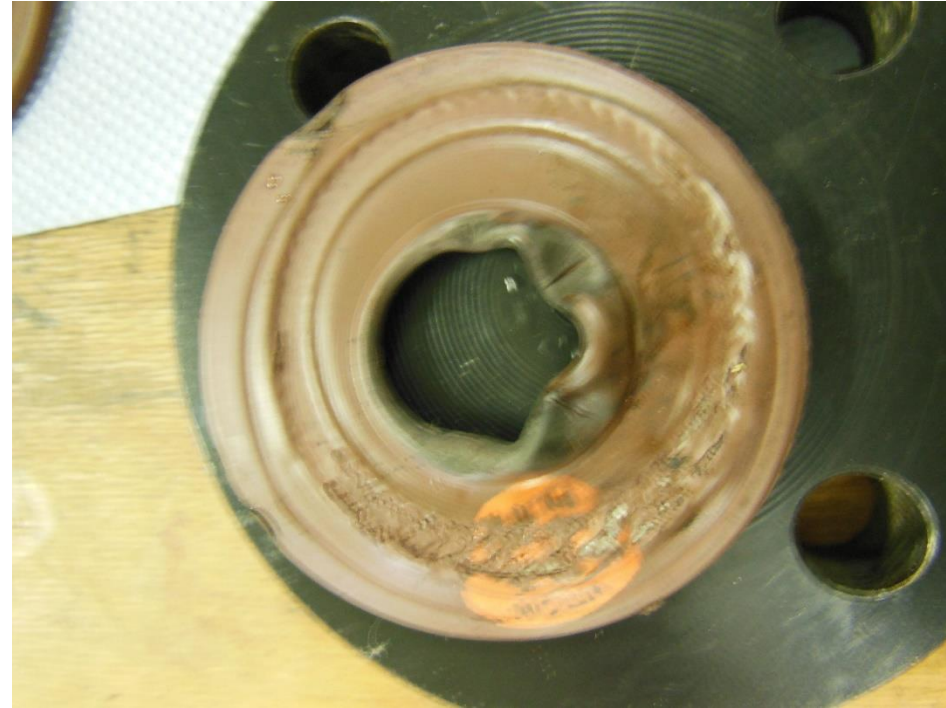
- Pullach: strong absorption of gases, de-gassing after pressure reduction, may be a reason for ruptures

Viton-gasket from exposition chamber after 1220 h!
→ type of material also of great influence

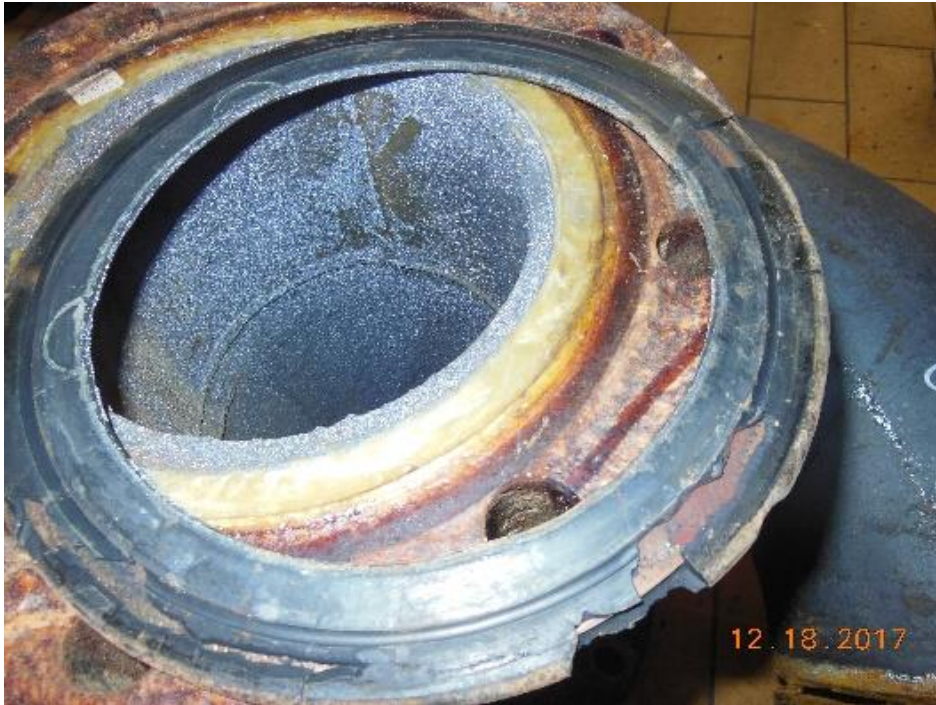
Destroyed gasket, EPDM (with scaling)
