Lessons learned from long-term corrosion investigations and -monitoring in saline thermal waters

Simona Regenspurg

Background: The geothermal research platform Groß Schönebeck

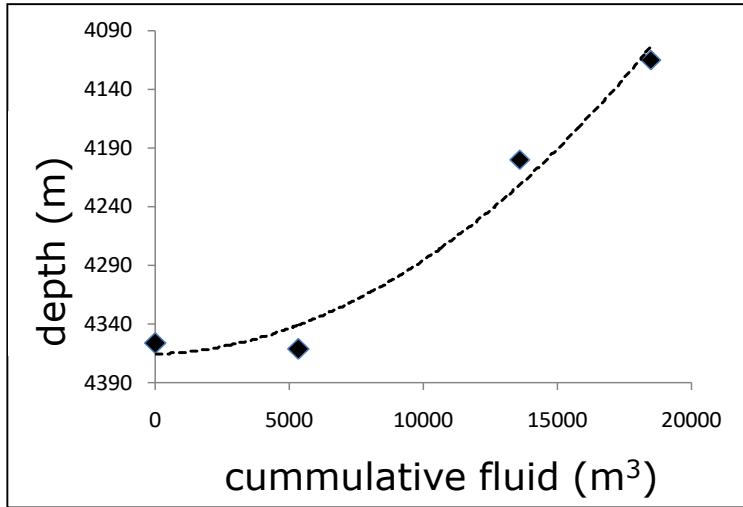
1. Reduced production rate and change of total depth over time.

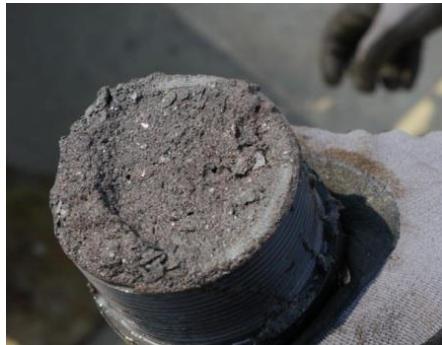
2. Bailer sampling indicated: filling of the production well (native copper, magnetite, barite...)

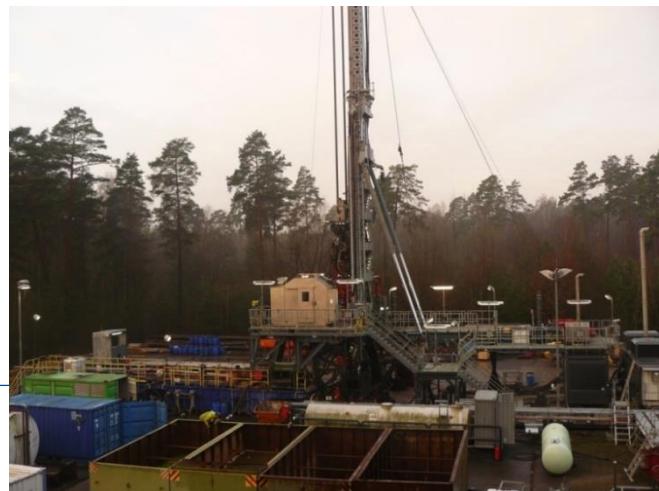
3. Removal of the fill:
1. Coiled tubing
 2. Work-over rig

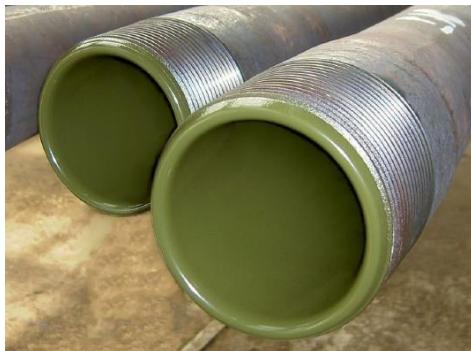
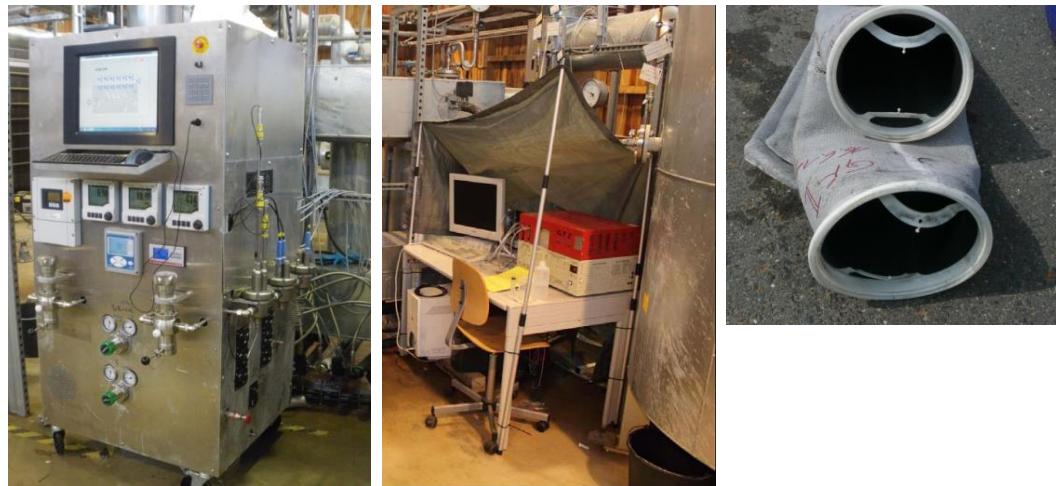
Material protection: epoxy resin (Vetco TK236)

- Non-polar, electric isolating coating
- Temperature resistivity: 200 ° C
- thickness: < 250 µm

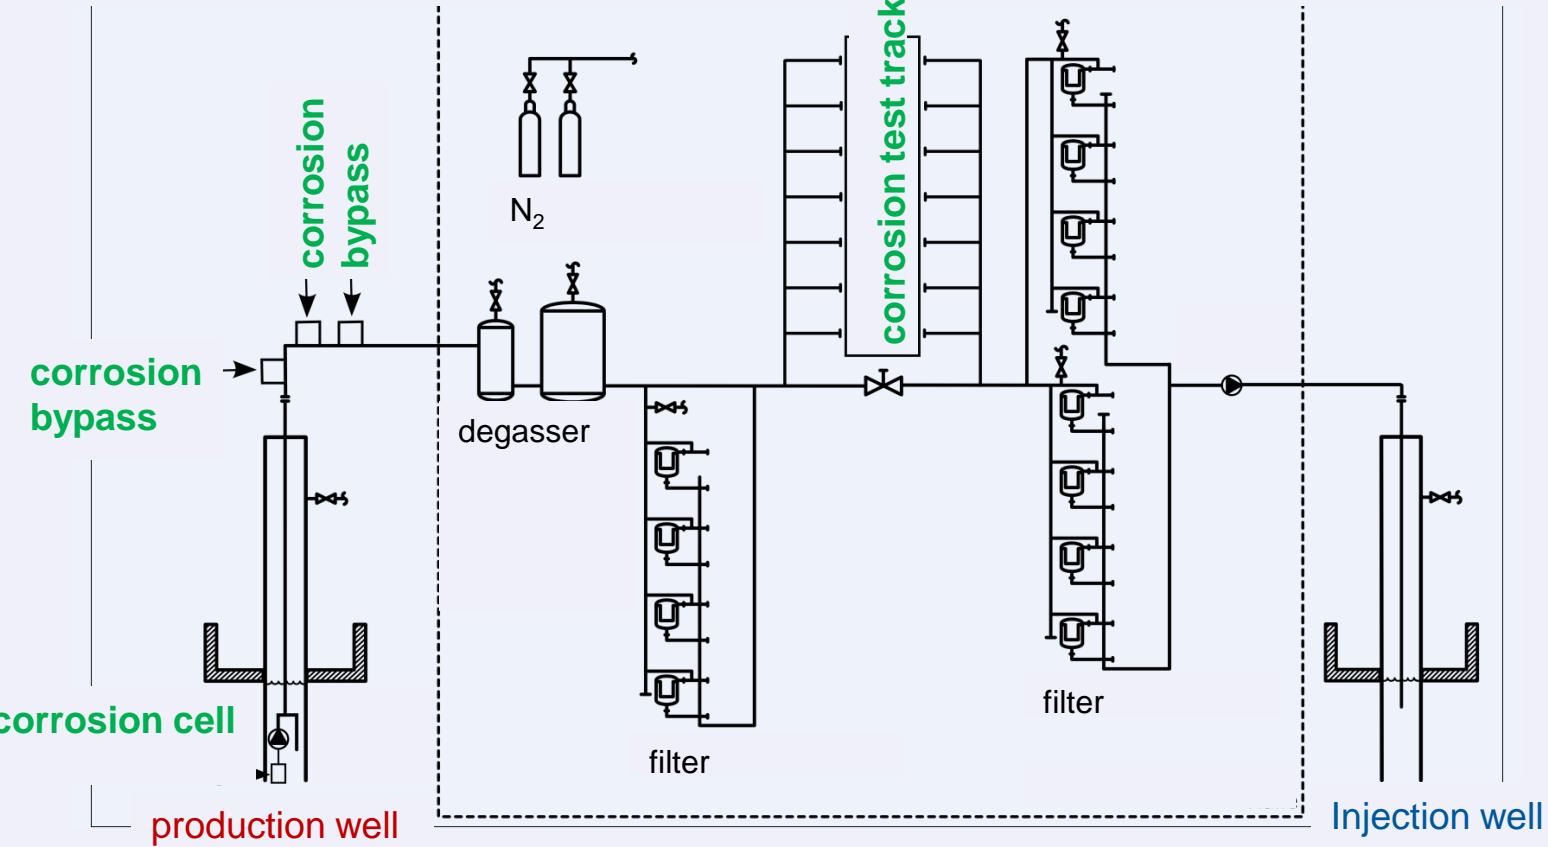
- 1. Corrosion test track (bypass)
 - 2. Component bypass
 - 3. Corrosion cell (below production pump)
- }
- planned
-
- 4. Coating instability (tubing)
 - 5. Wellbore: electrochemical corrosion
- }
- unexpected

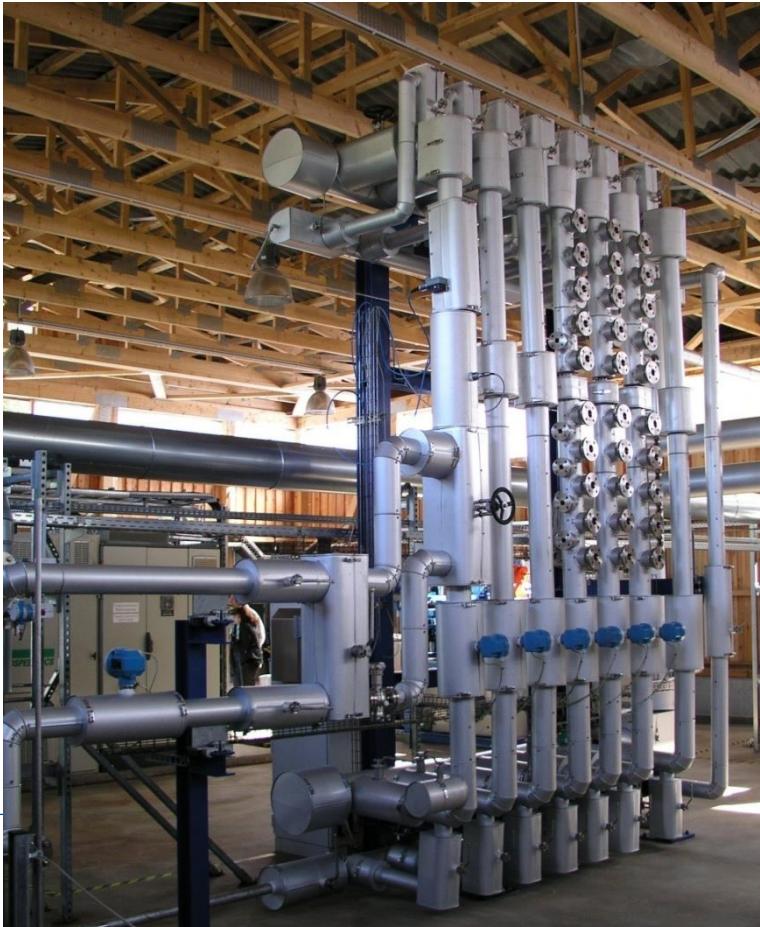
S+C materials (cast and modeling treatment)

alloy	corrosion	
G 45 Mo		<i>corrosion resistant</i>
G 45 Mo mod.	no pitting corrosion	<i>limited stable</i>
A59		<i>unstable</i>
A 254 SMO		
A625		
A825	matted but no pitting	
A31		
G625		
316 L	pitting corrosion	
C80L	general corrosion

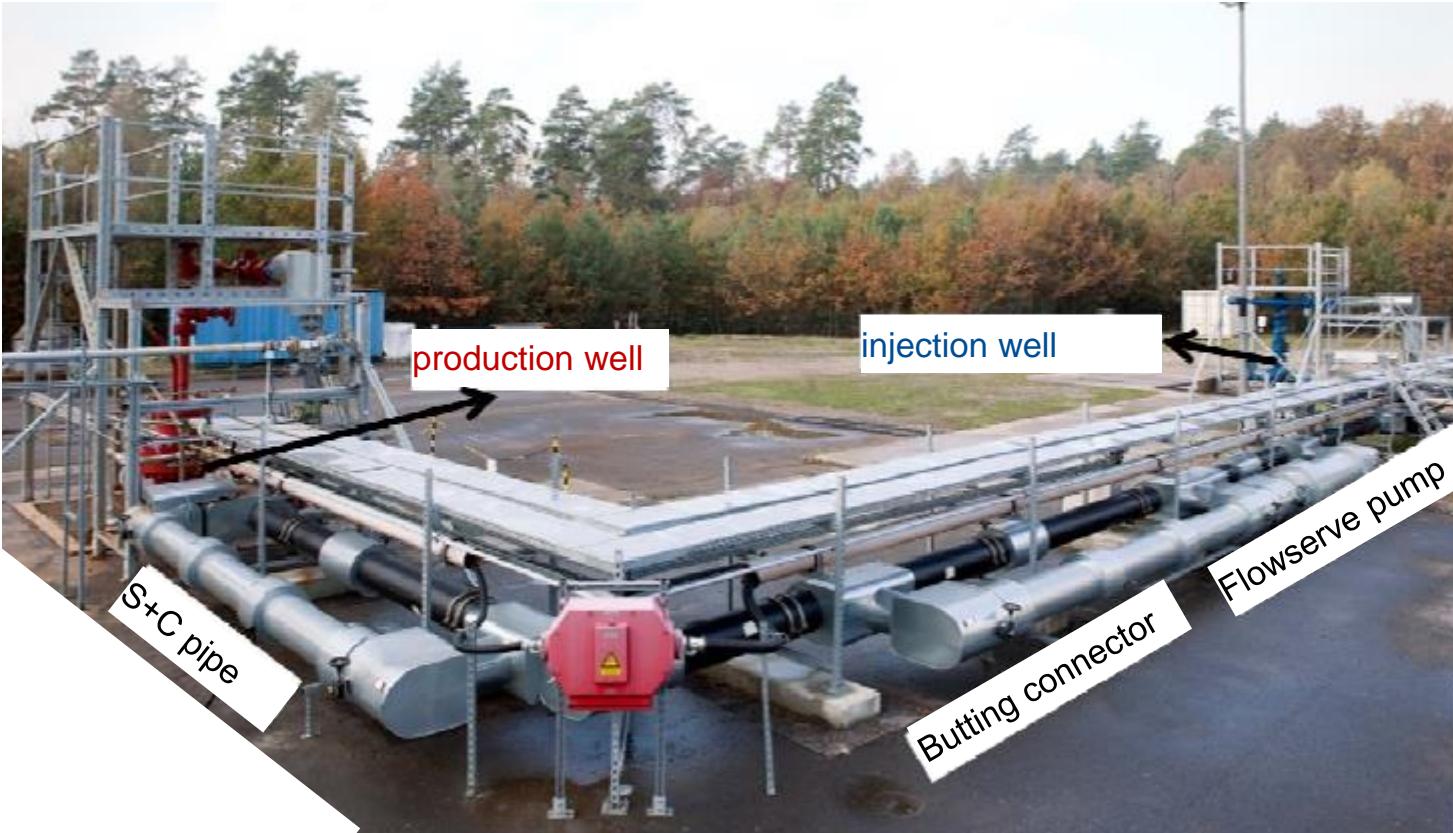
2. Components (bypass)

alloy	corrosion
Duplex cast material 1.4469	
Superduplex 1.4501	No corrosion
Austenitic cast steel 1.4408	
CrNiMo steel 1.4418	
Carbon steel parts	general corrosion (< 0.2 mm/a)

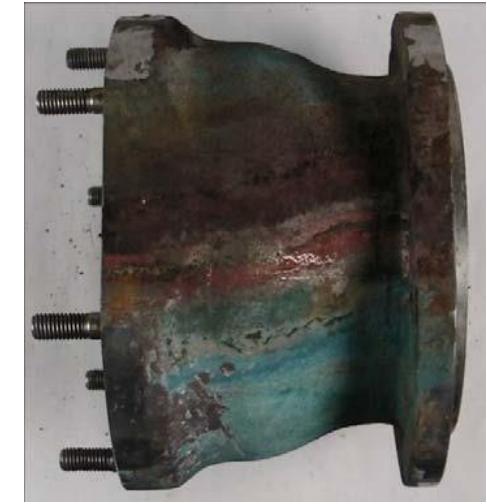
vane housing

Little corrosion

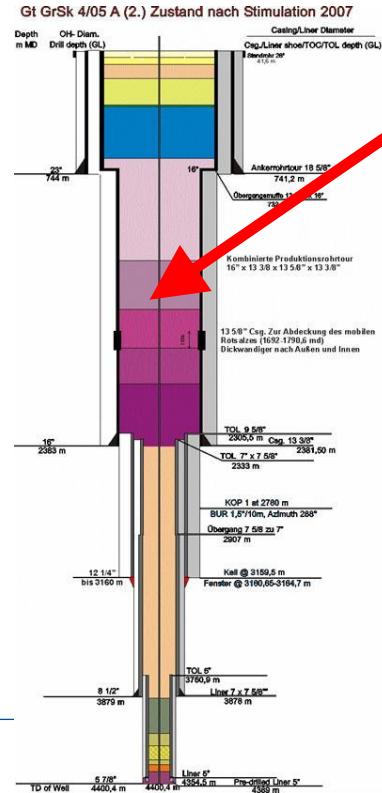
Production well

ESP in 1200 m

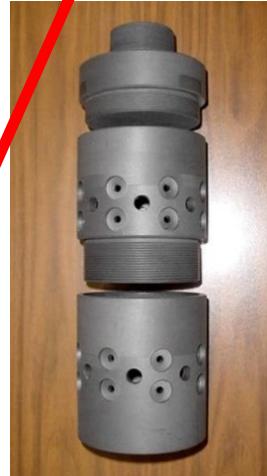
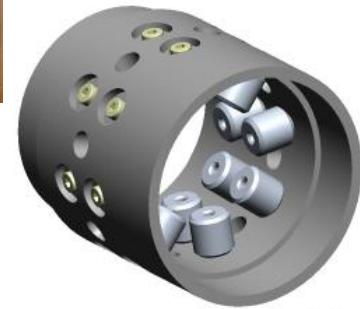
Corrosion test cell

- austenitic CrNiMo-steel A
- austenitic CrNiMo- Stahl B
- titanium gr. 12
- alloy 625
- alloy 59
- alloy 31
- alloy G45 Mo (7%)
- alloy G45 Mo (9,5%)

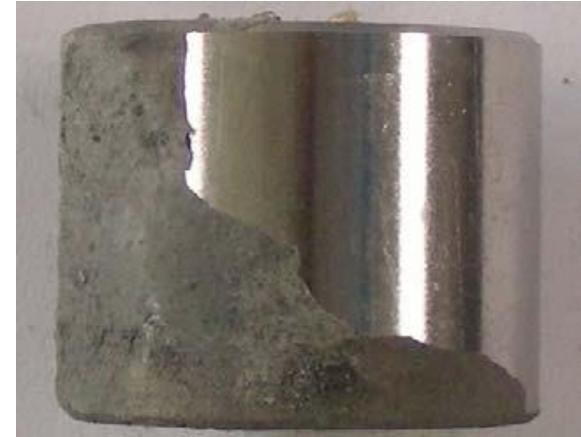
Example sample after 3 years exposure

- all samples were corrosion-resistant
→ possibly corrosion protection by scaling

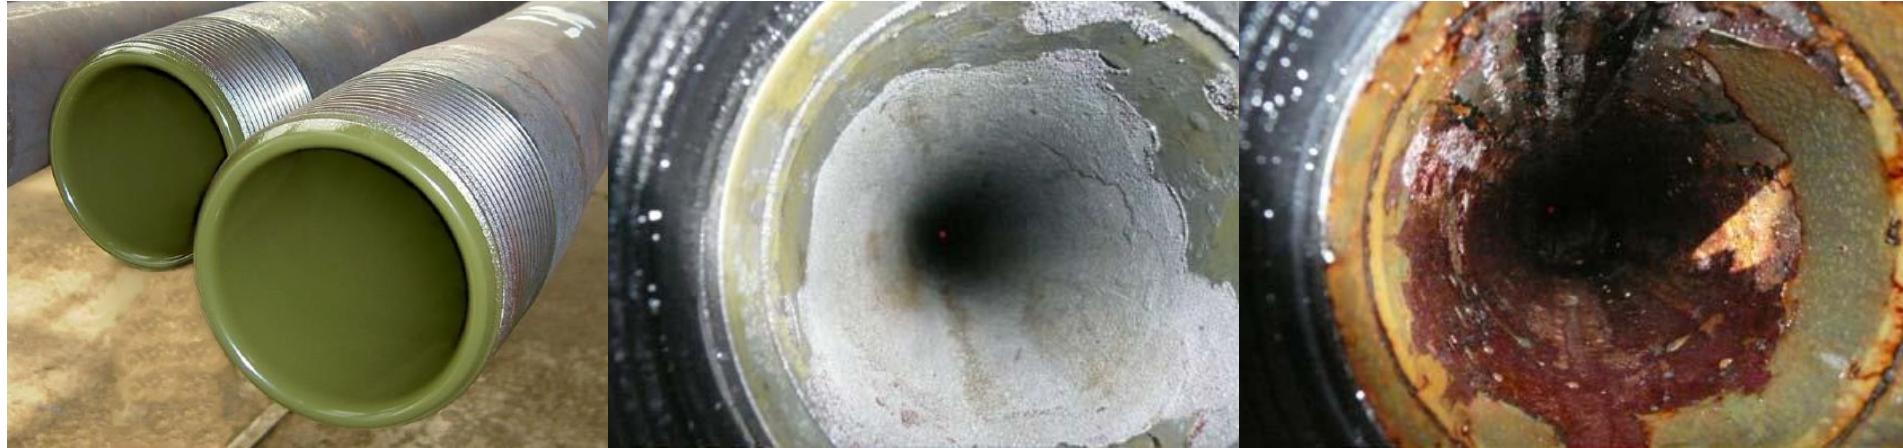
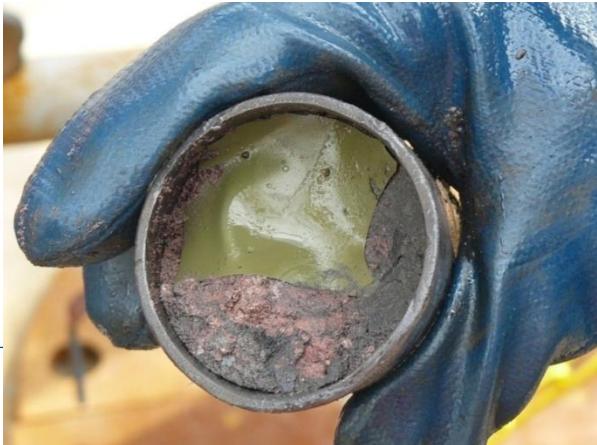
Tubing above ground: scaling (barite), intact coating; adherence > 20,68 Mpa

Tubing (<1200m) below ground:

some tubes: coating removal

→ decreasing adhesion between topcoat and primer (red) → defect of manufacturing

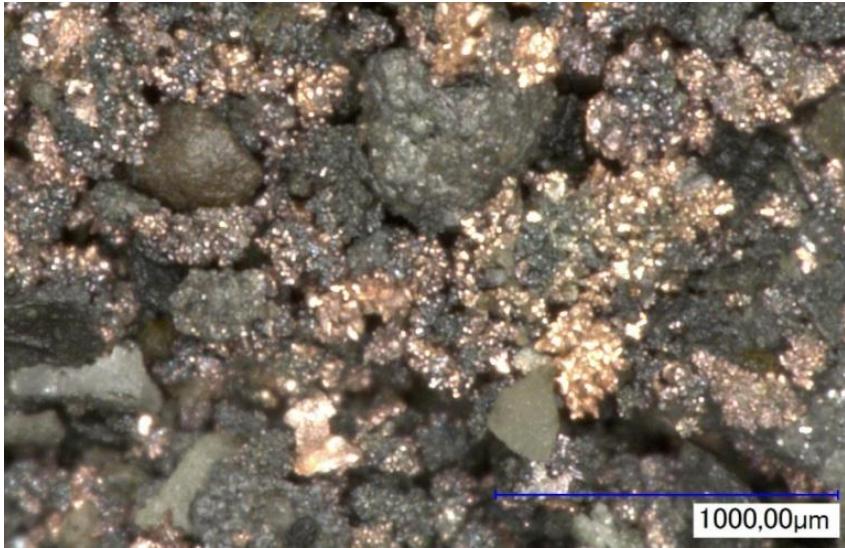
Corrosion products: High amounts of

- native copper (Cu)
- magnetite (Fe_3O_4)

found at well bottom

- hydrogen gas (H_2)

measured in the gas phase

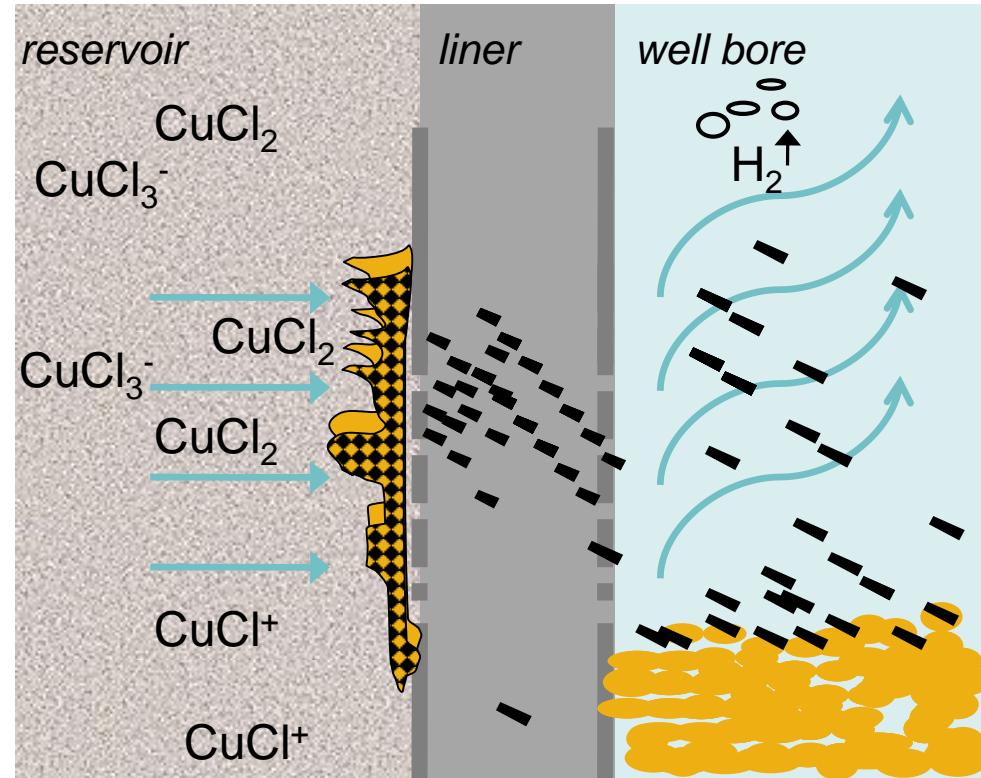
Corrosion process:

- Most tested materials (apart of carbon steel) proved to be corrosion resistant within the installations.
- Stability of coatings cannot be guaranteed.
- Main risk: Electrochemical corrosion of carbon steel casing with dissolved Cu.

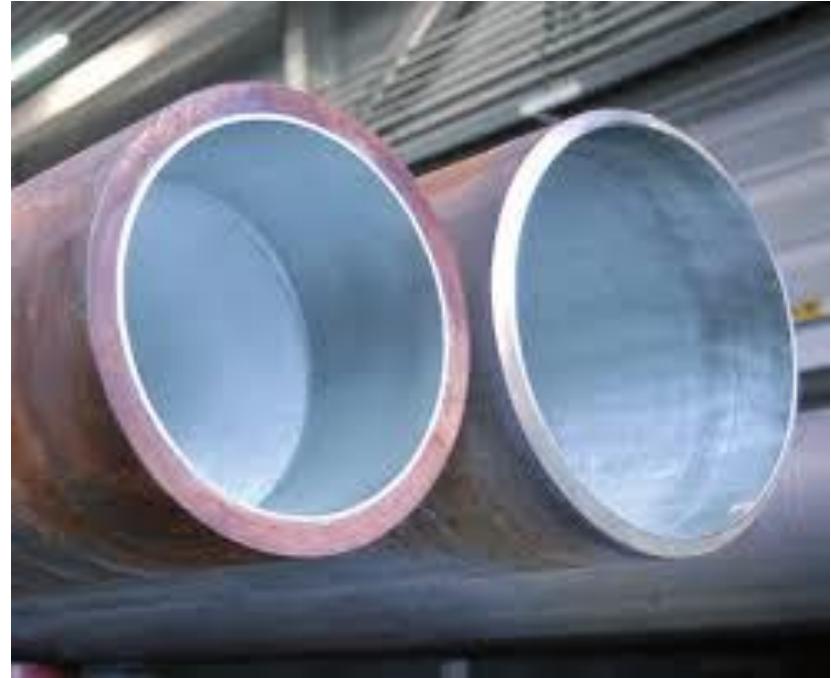
Cladded tubes

- Combining properties of C-steel (stability and ductility) with corrosion resistivity of highly alloyed steels
- Cladding of C-steel inside and/or outside by mechanical or metallurgical technique

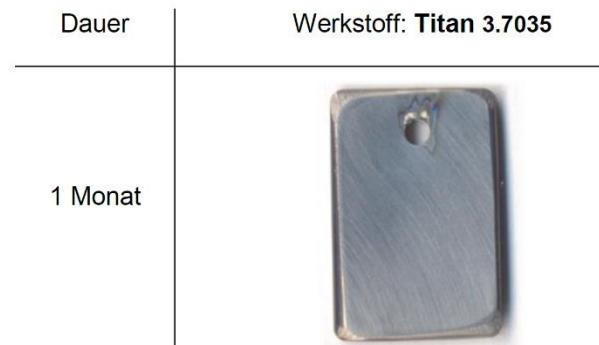
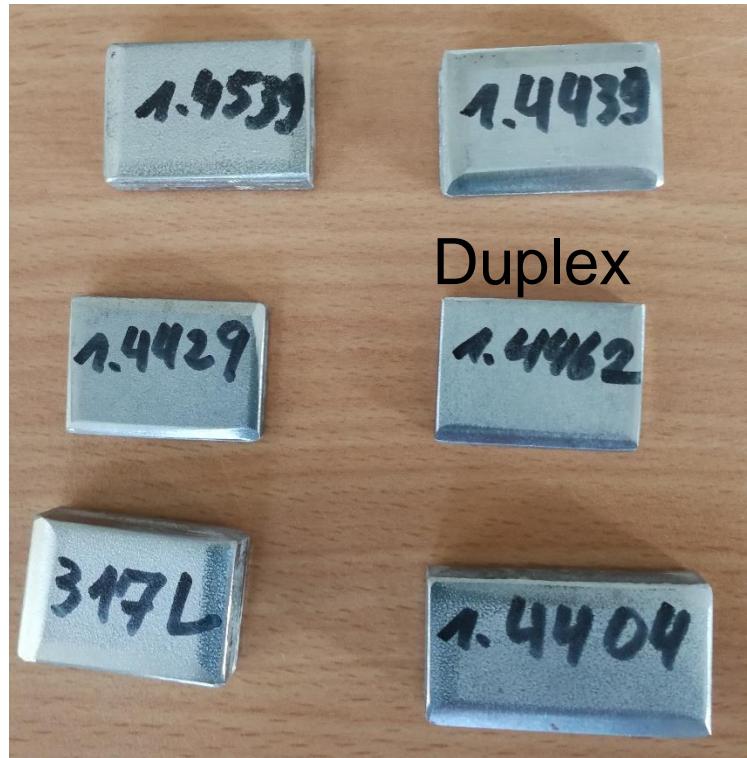
150° C, 1 mM Cu, 1.5 M CaCl₂, 2 M NaCl

- 5 Austenitic steel
 - 1 Duplex
 - Titanium
 - C-steel (St37)
- } Used for cladding

C-Stahl		Austenites and Duplex							
	Dauer	1.4438	1.4404	1.4429	1.4439	1.4462	1.4539		
24 h	7 days

- Reaction of Cu²⁺ with C-Steel increases over time
- Highly alloyed steels are corrosion resistant (slight crevice corrosion)

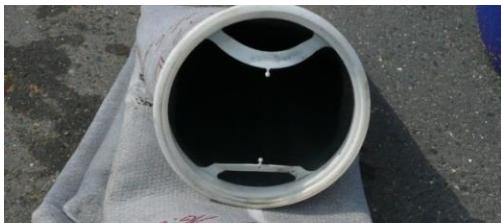
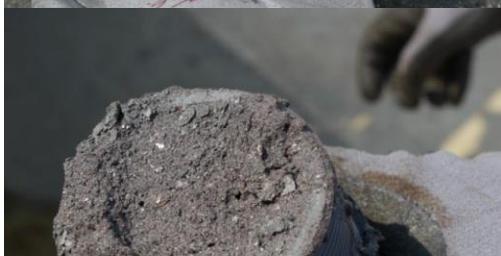
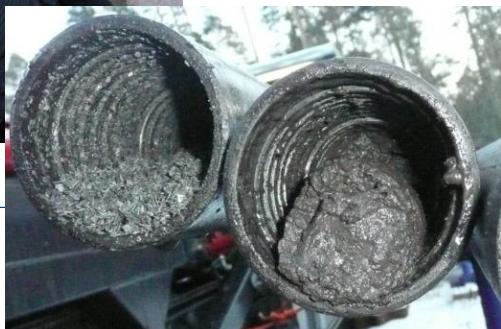
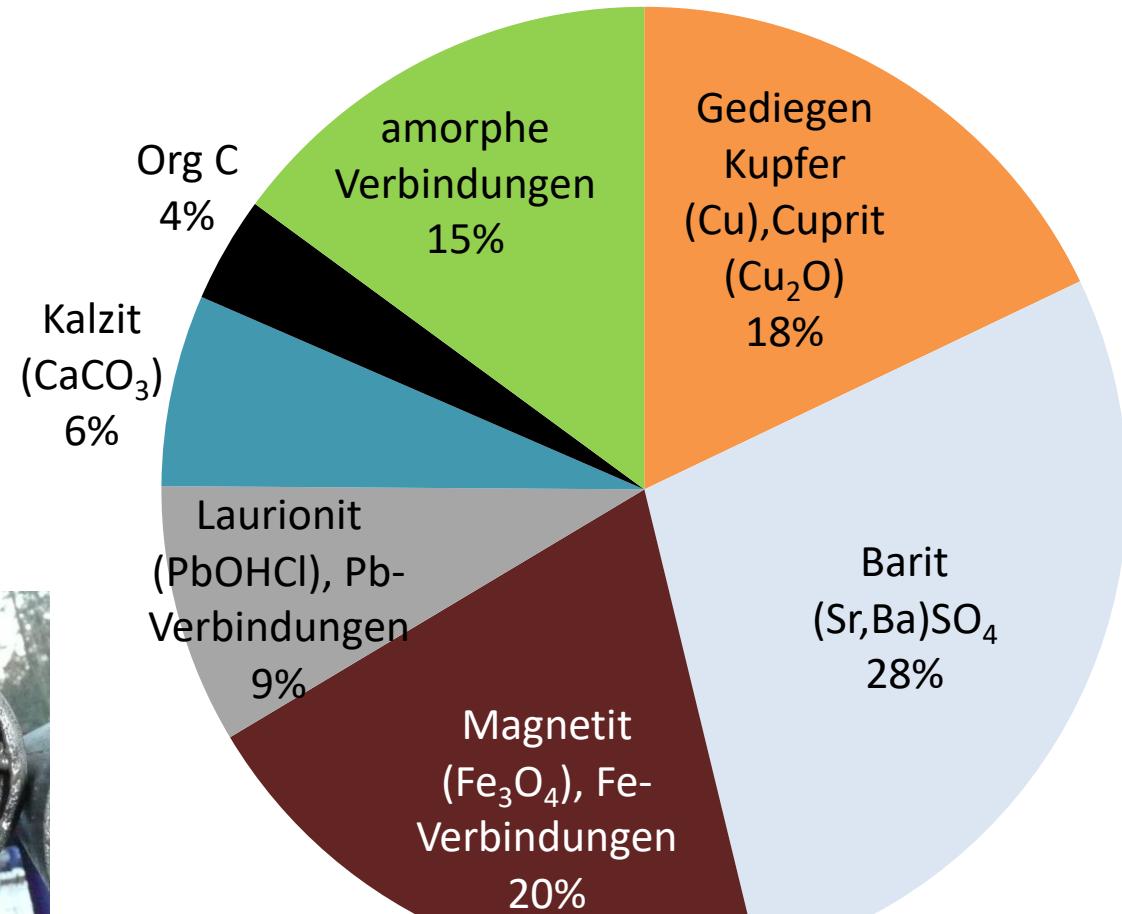
Total removed amount of solids (filter, bailer, well cleaning): ~ 600 L

Mean composition of all samples:
